The Strengthening of the Norbert Street Cable-Stayed Footbridge, Hutt Valley, New Zealand

*Duncan Peters BSc(Eng) M.IPENZ Registered Engineer
Senior Associate, Connell Wagner*

*Timothy Brook BE (Hons)
Engineer, Connell Wagner*

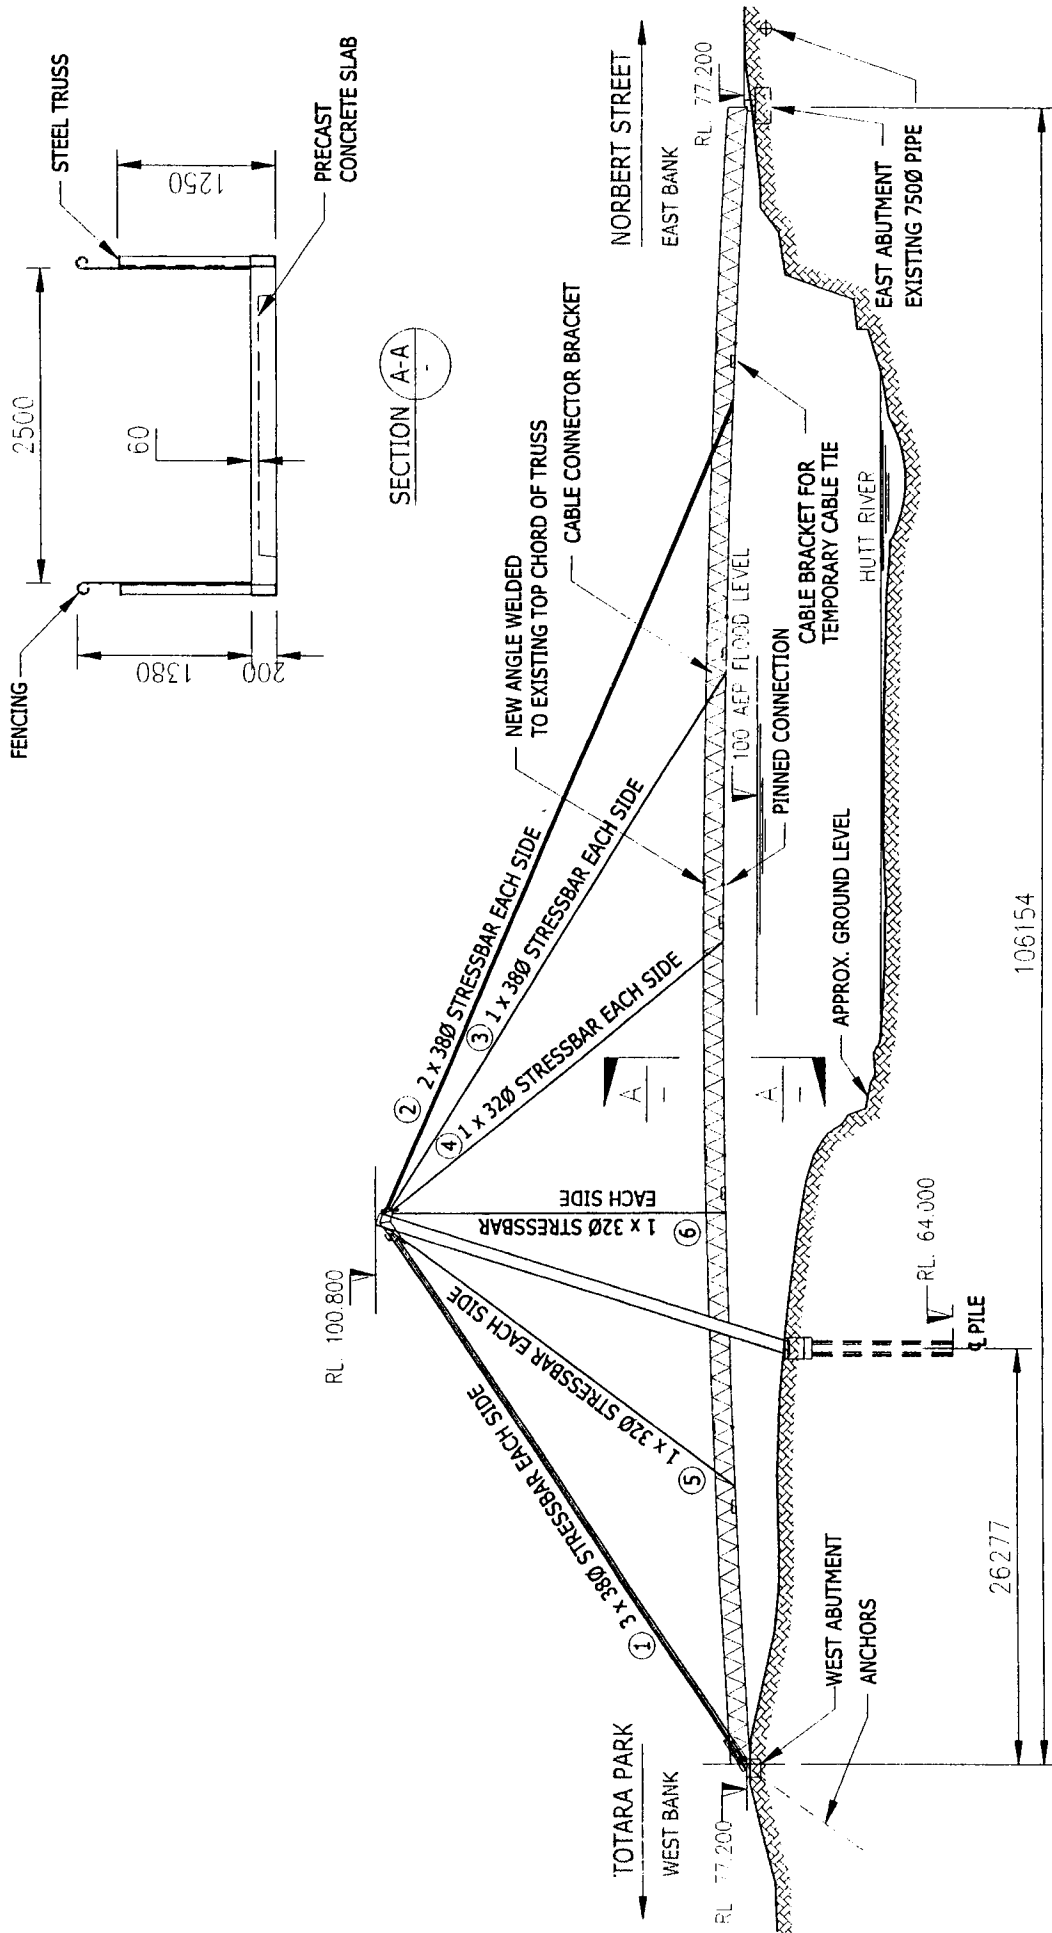
Figure 1 Elevation Of Strengthened Norbert Street Bridge

The deck is supported by an asymmetric radial arrangement of cables attached to the apex of an inclined A-shaped pylon (Figure 1). The pylon is tied back to the western abutment by two sets of three cables. Each original cable comprised a single 24mm or 28mm diameter galvanised steel wire rope. The ropes were anchored by placing their splayed out ends into drop forged sockets and filling the sockets with molten white metal. (White metal comprises 80% lead, 15% antimony and 5% tin). Apparently one of the anchorages was load tested during the bridge's construction.

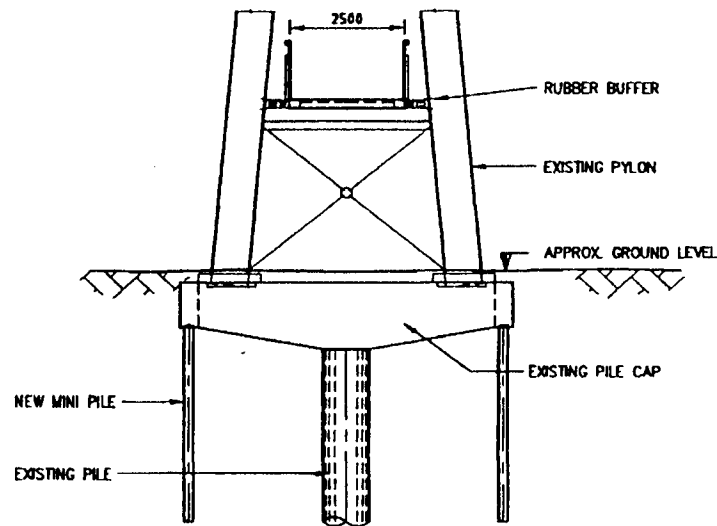
Figure 2: Elevation of Pylon

The pair of precast prestressed concrete pylon legs are bolted together at the apex and supported on a reinforced concrete hammerhead at the top of a bored cast in-situ concrete pile (Figure 2).

The bending moment capacity of the pile supporting the pylon was insufficient to resist transverse seismic and wind loading however the pile had adequate shear force capacity.

- One pressure grouted minipile to be installed at either end of the hammerhead supporting the pylon legs and connected to the hammerhead.

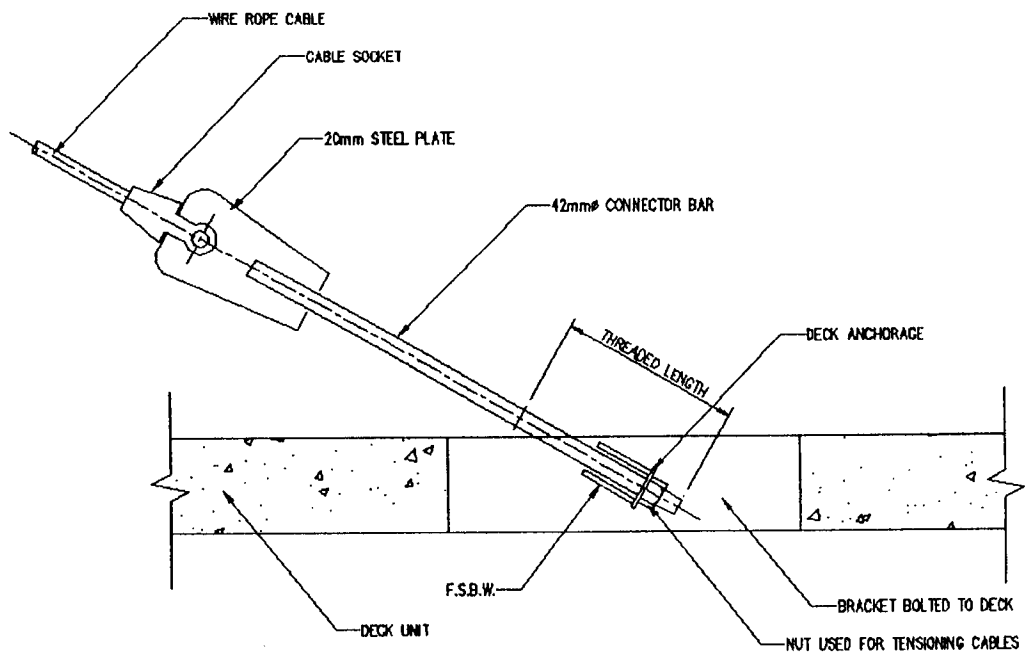
Figure 3: Elevation of Original Deck Anchorage

The steel plates attaching the cable sockets to the deck were narrower than the gap between the socket jaws in some instances (Figure 3). The absence of spacers between the plates and socket jaws gave rise to eccentric loading which could accelerate fatigue failure of the connections.

The downward kinks in the deck are probably due to there being insufficient length of threaded bar in the cable connectors to bring the deck units up to level during erection (Figure 3). Extension tubes have been placed between the nuts used to tension the cables and the anchorages on the deck in an attempt to alleviate the problem.

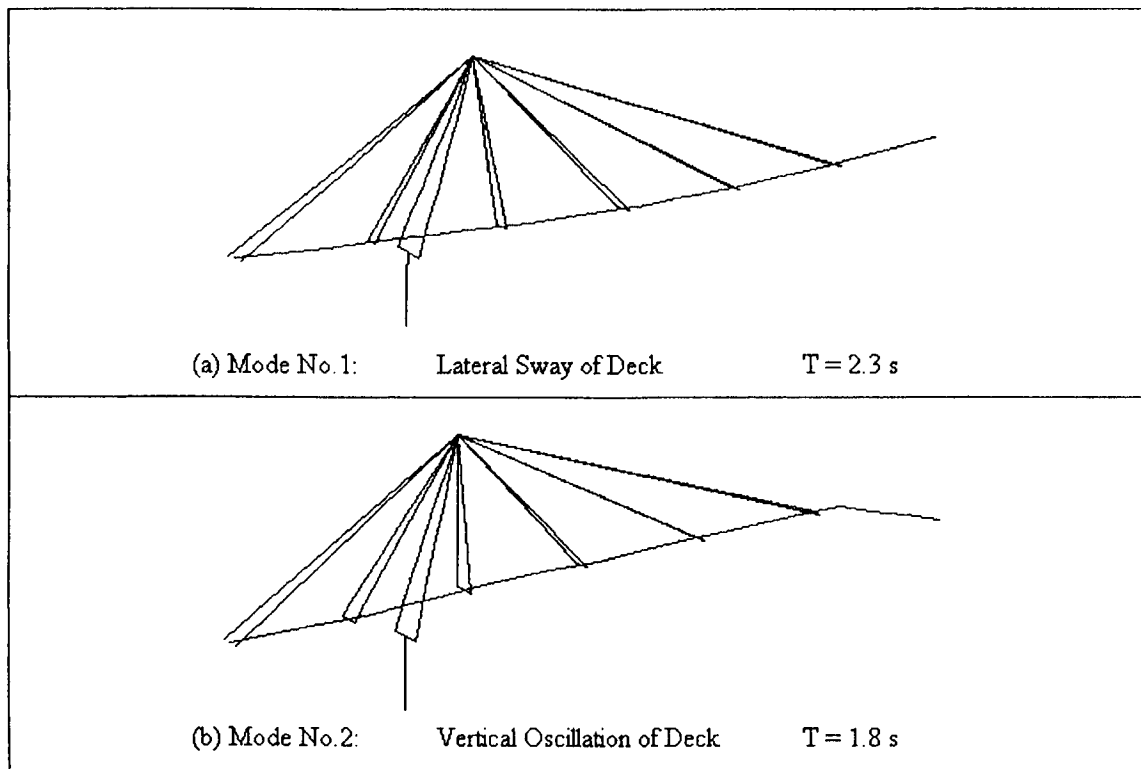
Figure 4: Primary Dynamic Mode Shapes of Bridge Before Remedial Works

The vertical oscillation of the bridge deck was represented by the second mode of vibration of the bridge (Figure 4). The computed period was 1.8 seconds which was close to the observed period of oscillation in moderate wind. The New Zealand loading code for buildings (2) recommends that for design, dynamic wind analysis be undertaken for structures with a fundamental period exceeding 1 second.

The measures proposed above reduce the fundamental period of the structure to less than 1 second thus obviating the need for a dynamic wind analysis (Reference 2).
